# SR 2 KIRKWOOD HIGHWAY

## PEDESTRIAN SAFETY STUDY

## FINAL REPORT

JANUARY 2015

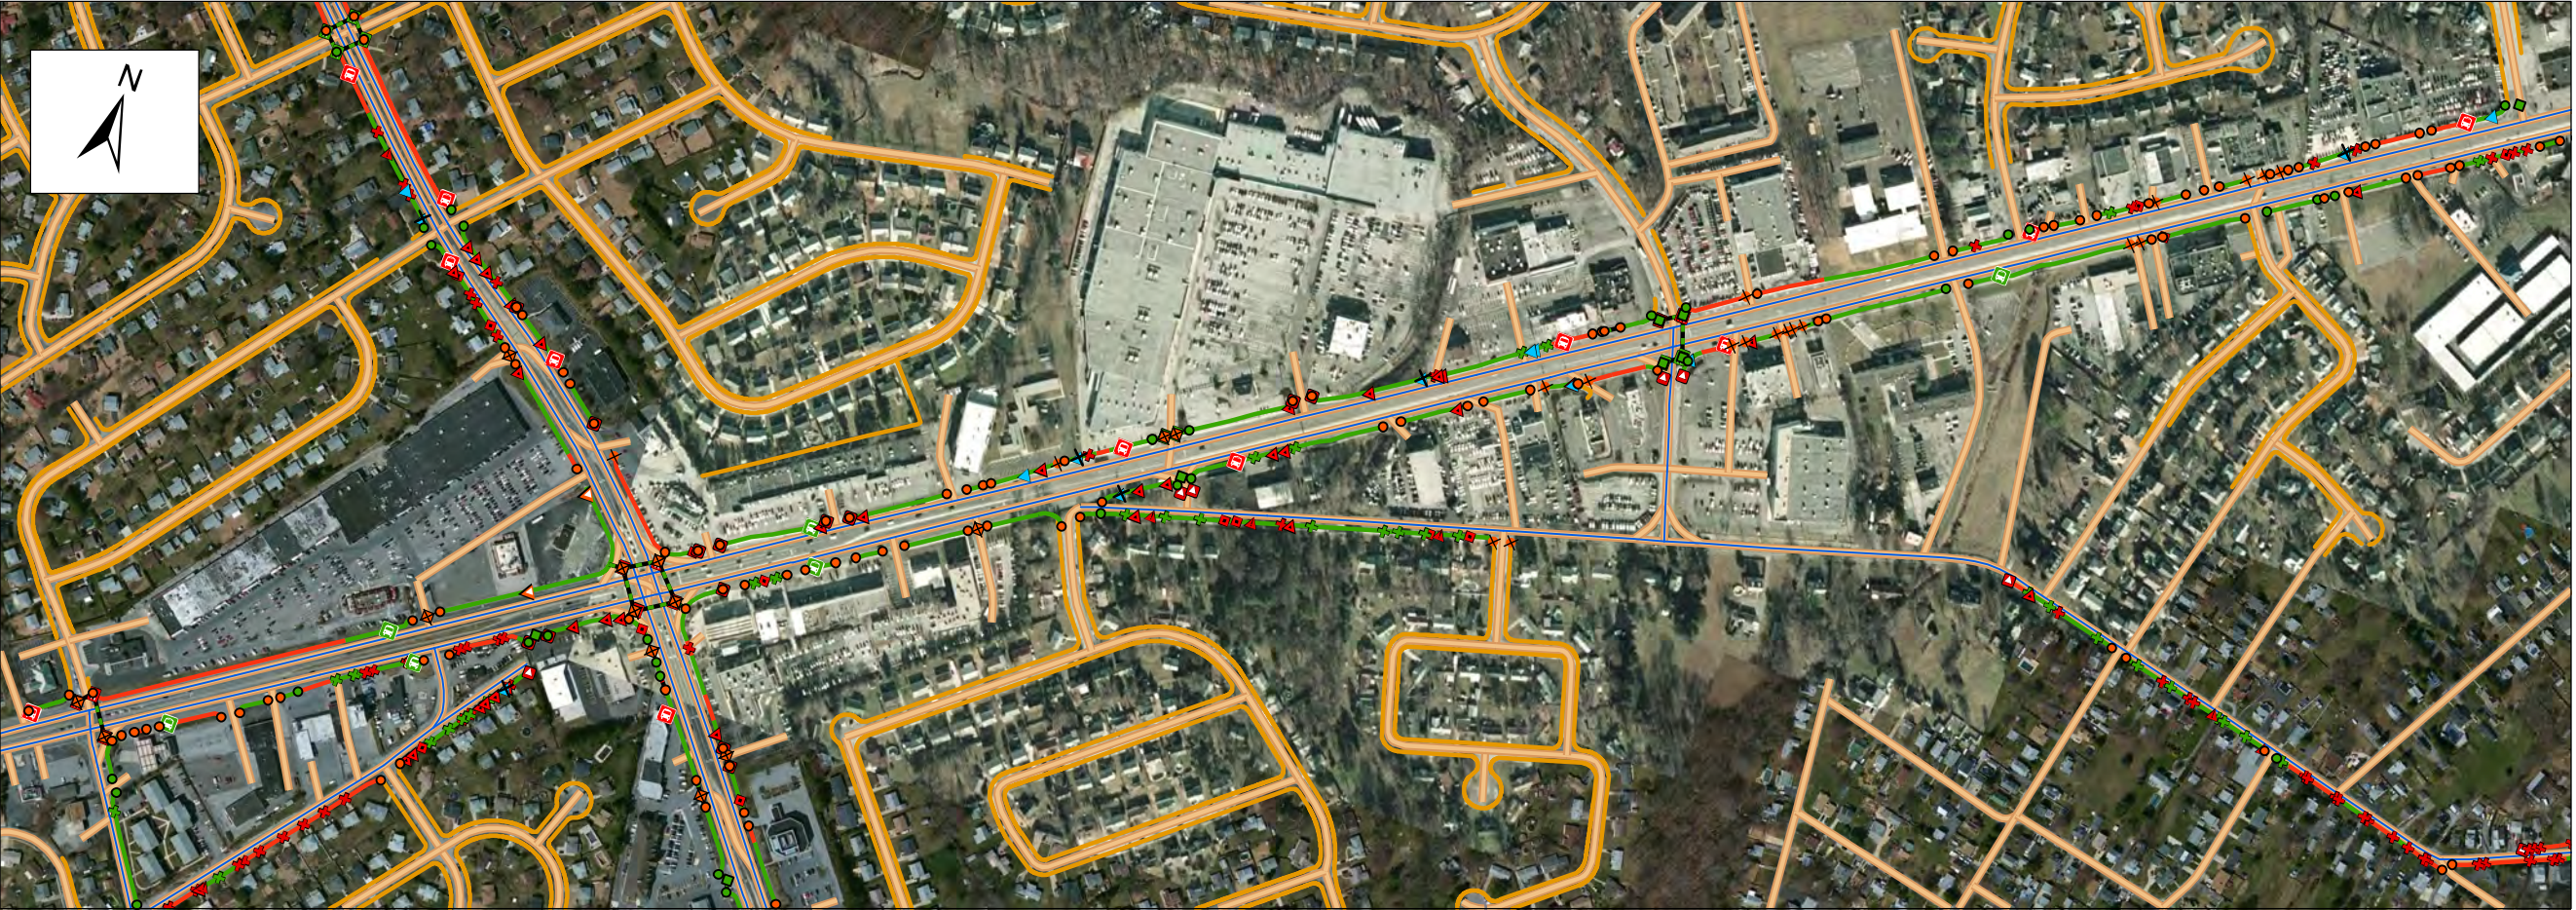
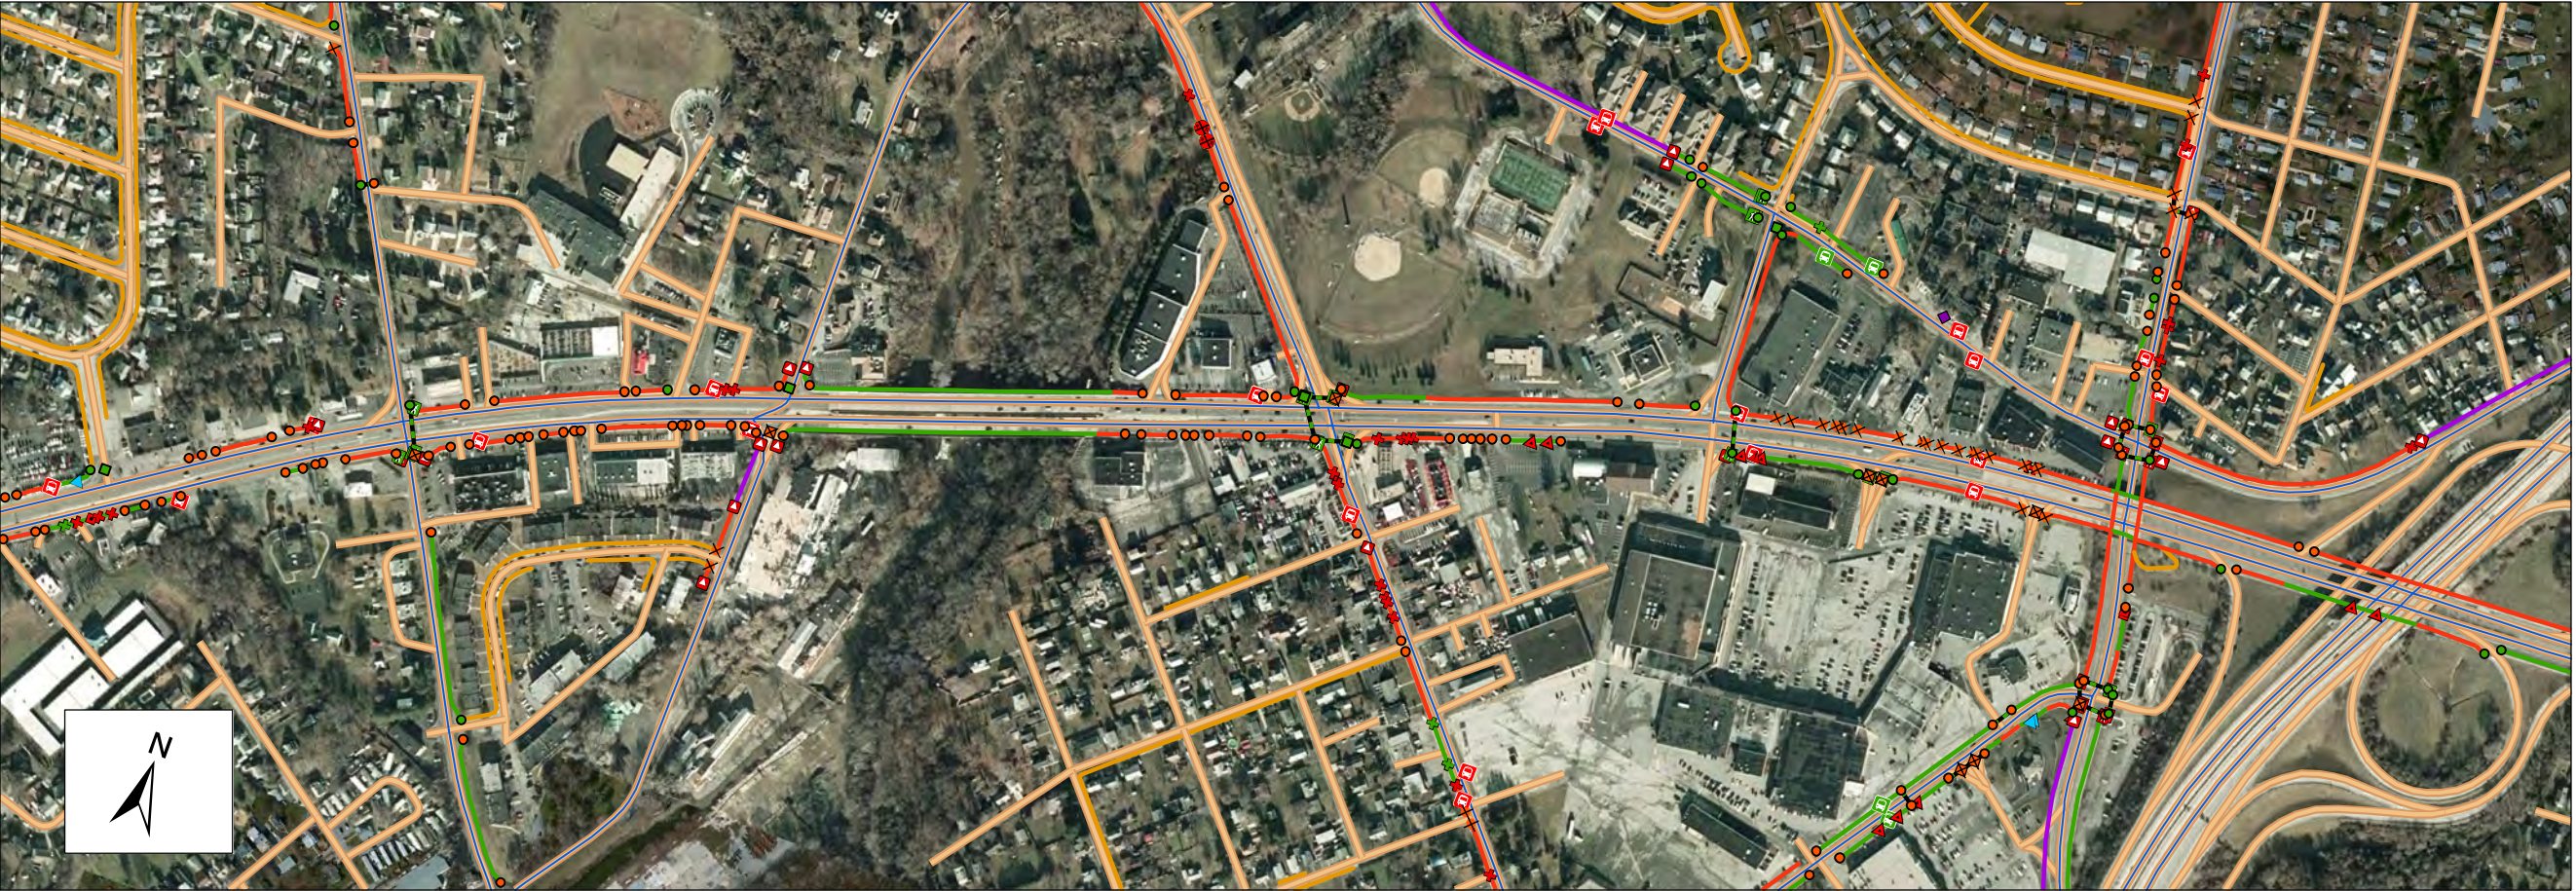
Figure 5 - SR 2, St. James Church Road/Griffin Drive to SR 141  
ADA Inventory (November/December 2011)

In November and December 2011, DelDOT conducted an ADA inventory and assessment of pedestrian accommodations along SR 2 from St. James Church Road/Griffin Drive to SR 141; therefore, a full evaluation of ADA compliance was not performed as part of the SR 2 Pedestrian Safety Study. A summary of the features collected by DelDOT's study are shown in **Table 5** and are shown graphically in **Figure 5**. As shown, 84 percent of curb ramps and 43 percent of sidewalk within the study limits are non-compliant.

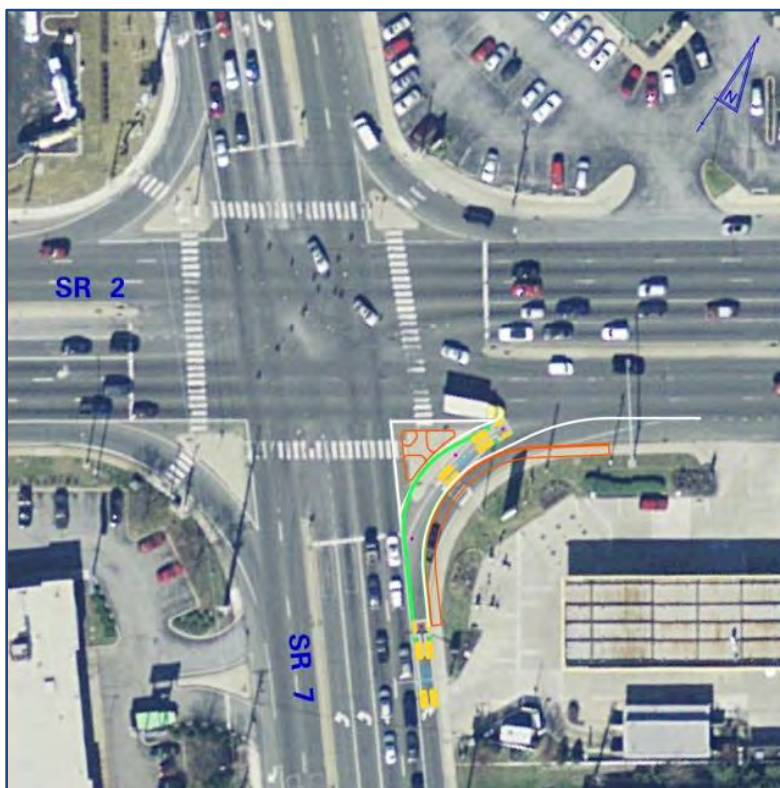
**Figure 6 – SR 2 at SR 7 Reduced Northbound Right-Turn Radius**

**Northbound Right-Turn Evaluation:** The existing yield condition and channelizing island provided for the northbound SR 7 right-turning movement at SR 2 allows northbound right-turning vehicles to continue moving through their turn without stopping at the intersection, reducing acceptable gaps for pedestrians to cross the channelized northbound right-turn lane and increasing the potential for pedestrian crashes. Additionally, no acceleration lane is provided along eastbound SR 2 to accommodate accelerating northbound right-turning movements from SR 7, increasing the potential for northbound right-turn rear end crashes. During the three-year study period from January 2010 to December 2012, 146 crashes were reported at SR 2 at SR 7, including 21 northbound right-turn rear end crashes. Signalizing the northbound SR 7 right-turning movement at SR 2 (and providing a right-turn overlap with the westbound left-turn phase) would create a stop condition for northbound right turns in advance of the crosswalk and potentially create a more desirable crossing environment for pedestrians on the southeast corner of the intersection. Signalizing the movement would require tightening the turning radius on the southeast corner of the intersection, removing the channelizing island, and realigning the crosswalks on the south and east legs of the intersection. This option would also reduce the potential for northbound rear end crashes by providing positive guidance to these motorists when they have the right-of-way and reducing the need for right-turning vehicles to yield to opposing traffic.

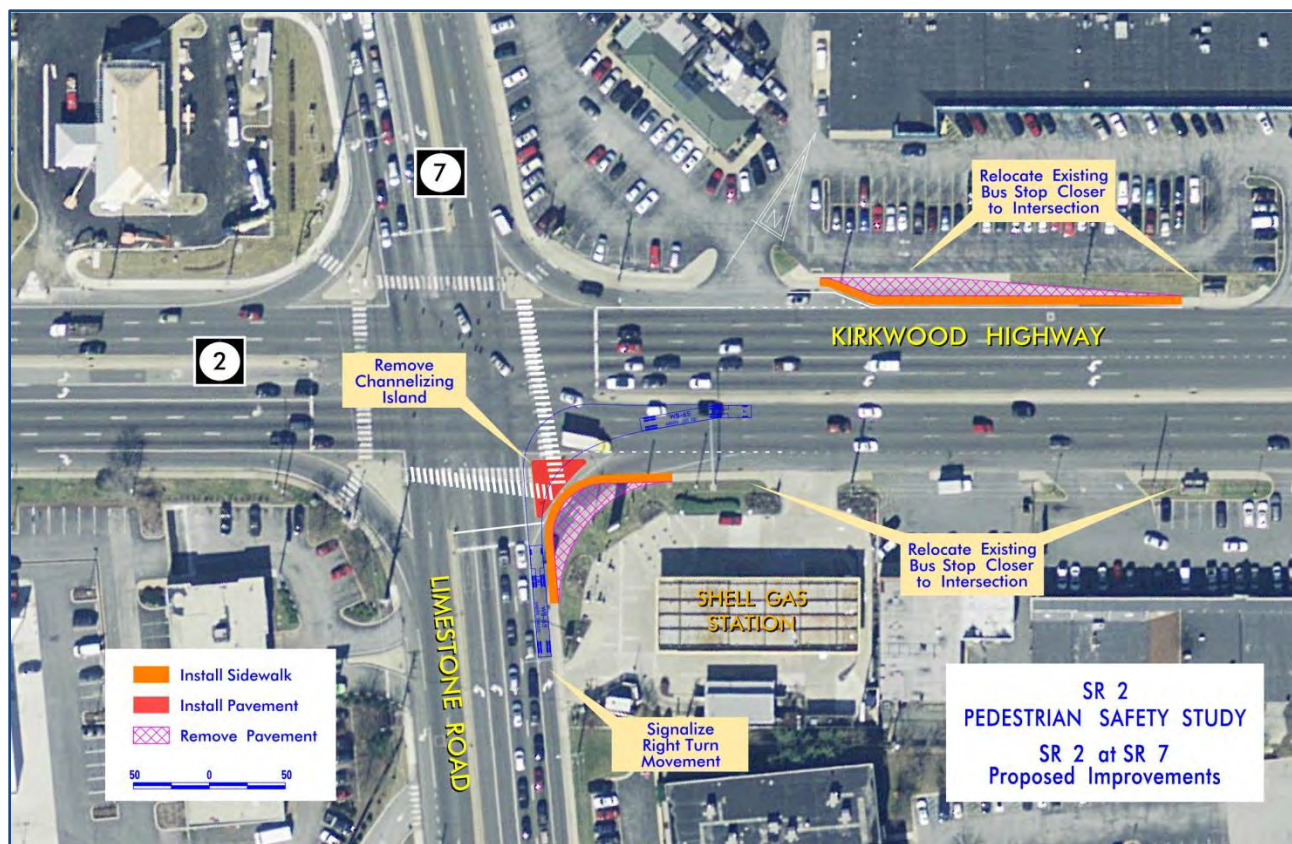
A conceptual sketch of the east leg of the SR 2 at SR 7 intersection showing the relocation of bus stops, signalization of northbound SR 7 right turns at SR 2, and the tightening of the turning radius on the southwest corner of the intersection is shown in **Figure 7**.

**FIGURE 7 - SR 2 at SR 7 Proposed Improvements**

Similarly, relocating the westbound SR 2 bus stop at SR 7 was considered. Farside bus stop locations are generally preferred by DTC; however, relocating the bus stop from the near side of the intersection to the far side would provide three bus stops along westbound SR 2 from SR 7 to St. James Church Road/Griffin Drive, creating less than desired bus stop spacing. Additionally, the existing near side stop serves the Mill Creek Shopping Center, with a high ridership. A preliminary review of the existing private driveways and land uses along the north side of SR 2 east of SR 7 indicates the westbound SR 2 bus stop could be relocated closer to the existing crosswalk at SR 7 by reducing the westbound SR 2 right-turn storage length approaching SR 7 and extending the curb line closer to the westbound travel lanes. Based on peak hour field observations, westbound SR 2 through queues frequently extend beyond the existing right-turn lane and block right-turning vehicles from entering the turn lane. Although reducing the length of the right-turn lane will increase the frequency of blockages, reducing the length of the right-turn lane slightly is not anticipated to significantly impact operations. This improvement will require modifications and impacts to the retaining wall located on the northeast corner of the SR 2 at SR 7 intersection. For these reasons, relocating the westbound SR 2 bus stop at SR 7 closer to the intersection is recommended. Installing additional signage at the bus stop to encourage transit riders and pedestrians to cross at the intersection is recommended as a short-term improvement.

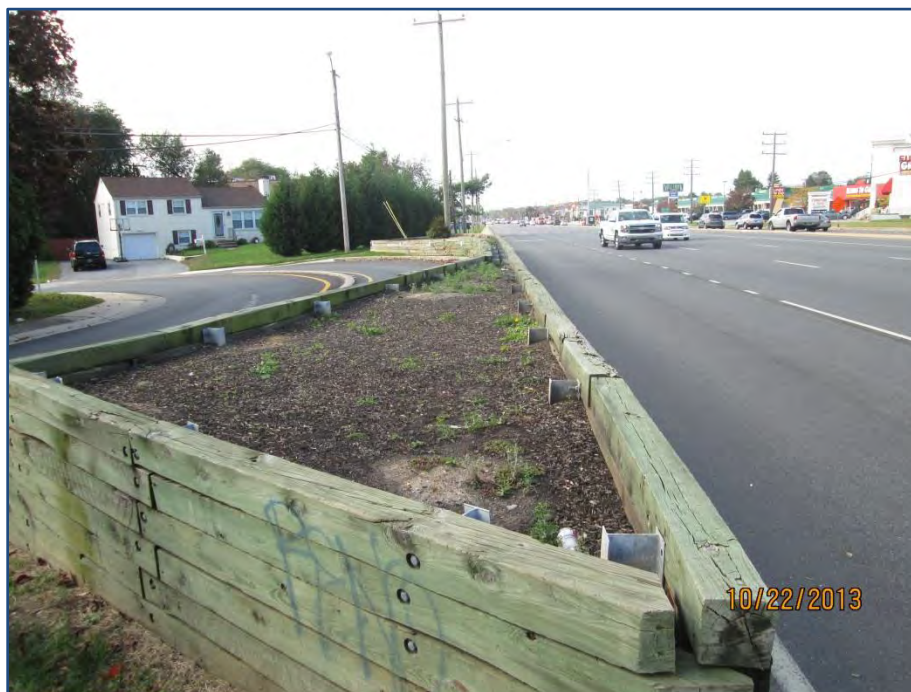
**Evaluation of Elevated Landscaping Bed:** Along the south side of SR 2, approximately 200 feet west of the Kirkwood Plaza signal, an elevated landscaping bed obstructs the path of a pedestrian traveling along the roadway (see **Photo 7**). The landscaping bed is surrounded by stacked wood posts, which are supported with steel beams driven into the ground. The elevated landscaping bed, which provides physical separation between the eastbound SR 2 travel lanes and Old Capitol Trail/Monica Boulevard, is approximately 31 inches wide at its narrowest point and about 30 inches tall. A sidewalk with two crossings of Old Capitol Trail/Monica Boulevard is provided on the south side of the landscaping bed. Based on field observations, the majority of pedestrians are walking along the south side of the landscaping bed and not within the eastbound SR 2 travel lanes. Additionally, there is evidence of vehicles traveling along Old Capitol Trail striking the landscaping bed.

**Photo 7 – Elevated Landscaping Bed along South Side of SR 2 west of Kirkwood Plaza (Looking West)**

The elevated landscaping bed is not crashworthy, is located within the clear zone, and creates a diversion for pedestrians traveling along the SR 2 corridor. As such, removing the landscaping bed and providing a crashworthy treatment and sidewalk along SR 2 is recommended. This will likely involve installing guardrail along SR 2 and/or Old Capitol Trail/Monica Boulevard and potentially narrowing the eastbound SR 2 right-turn lane approaching Old Capitol Trail to provide additional width for the guardrail and sidewalk (the existing right-turn lane is approximately 14 feet). Consideration should also be given to eliminating one of the travel lanes along Old Capitol Trail/Monica Boulevard (i.e., provide a one-way roadway segment) to provide additional width for the guardrail and sidewalk. Additional investigations are required to determine the most appropriate treatment to address the deficiency.

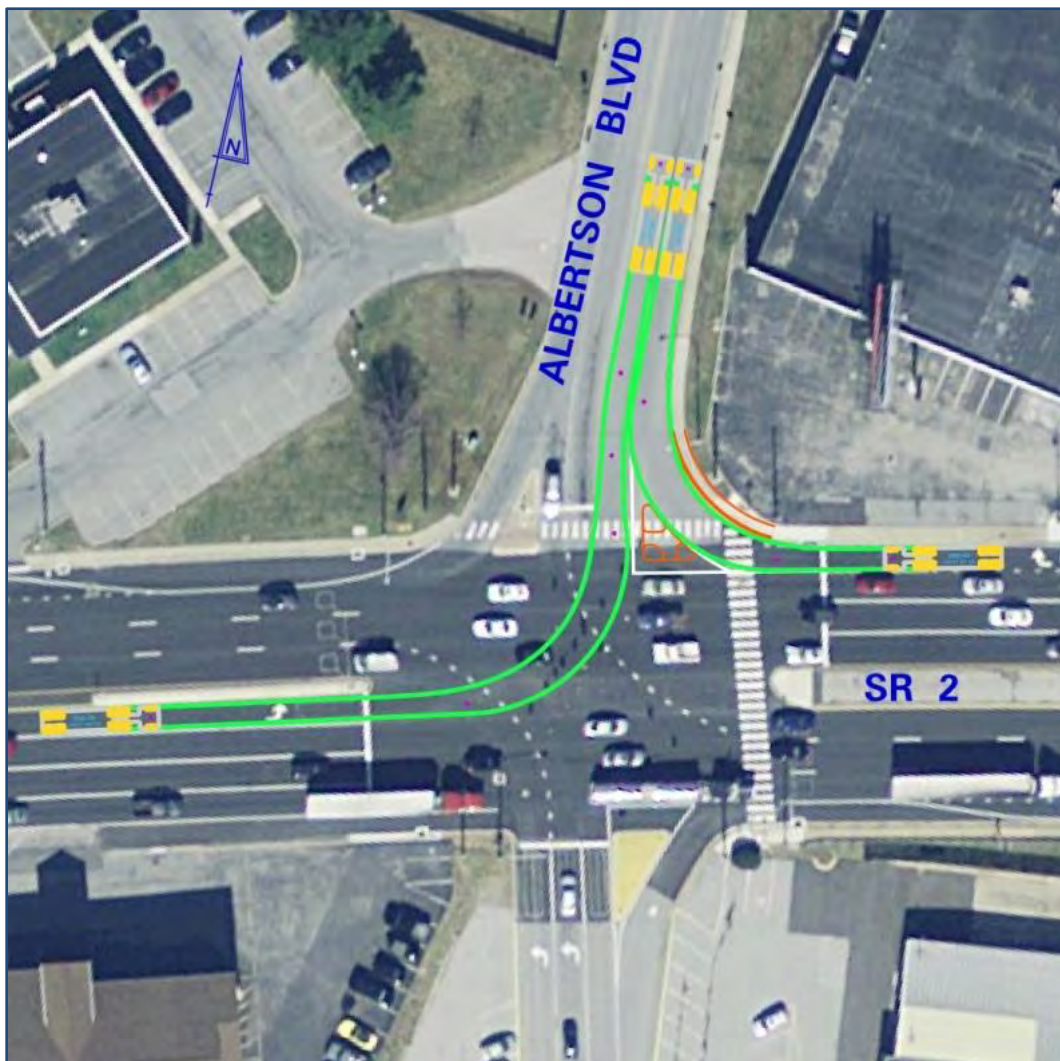
Figure 8 – SR 2 at Albertson Boulevard Concept
